## **ADRE® for Windows - instrumental in solving a complex vibration problem on a boiler feedwater pump**

*by Ibrahim Al-Ajmi  
Vibration Supervisor  
Operations  
Engineering Dept.*

*Saudi Consolidated  
Electric Company,  
Kingdom of Saudi Arabia*

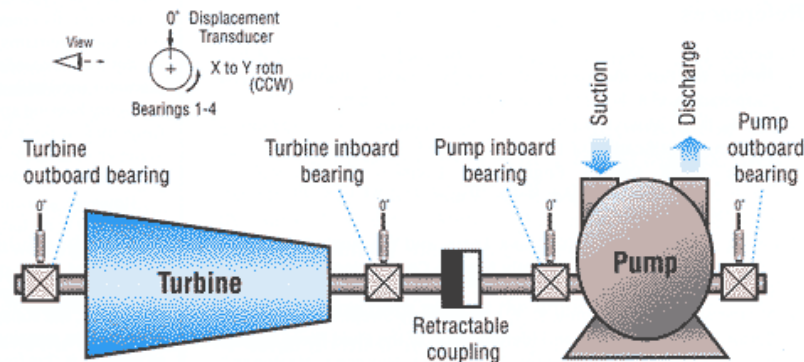
**Figure 1. Unit 4 main boiler feedwater pump machine train configuration.**

The 4-stage Delaval pump is driven by a steam turbine operating at 5500 rpm through a retractable

coupling (Figure 1). The pump suction flow (machine load) is controlled by adjusting the turbine speed. Proximity probes are mounted on the bearings in the vertical direction and connected to the Bently Nevada vibration monitors. Figure 1 shows the basic configuration of the Main Boiler Feedwater Pump.
